Penketh
Parish
Council

Penketh Swimming Pool and Community Centre

OPTIONS STUDY
February 2022

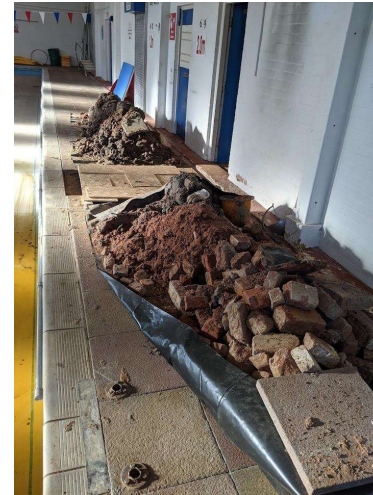
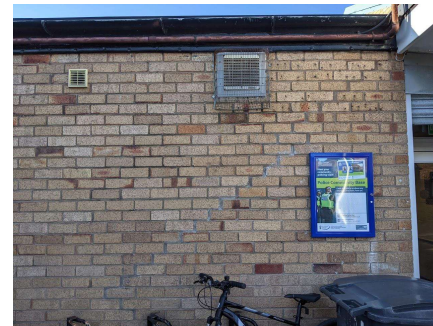
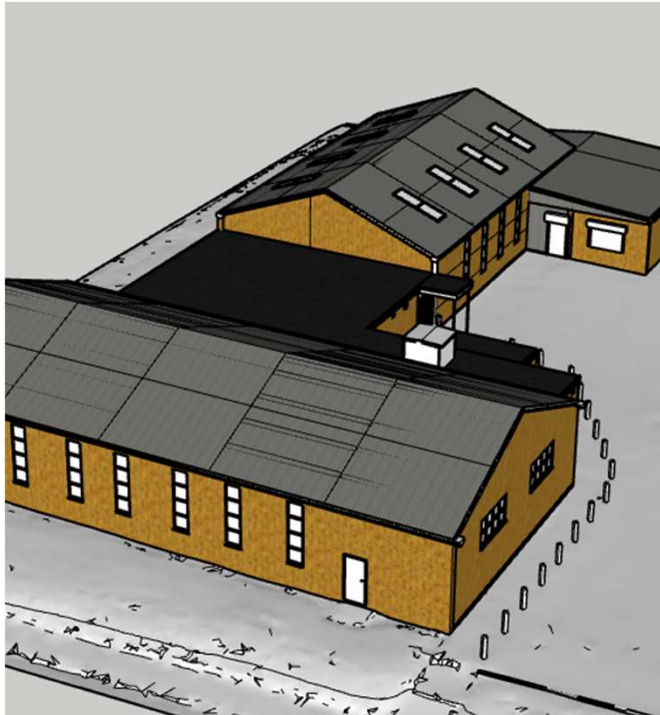
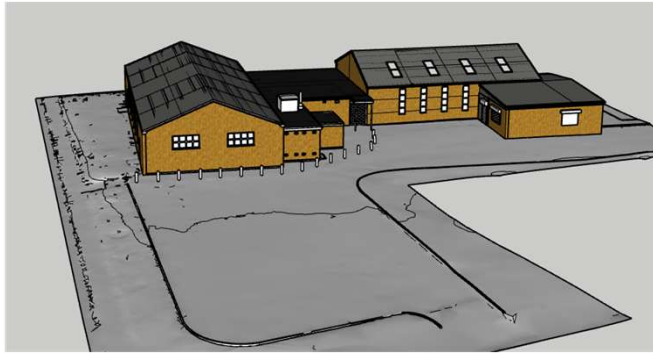
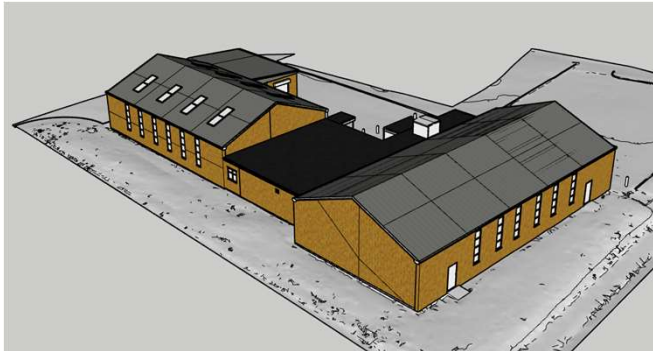
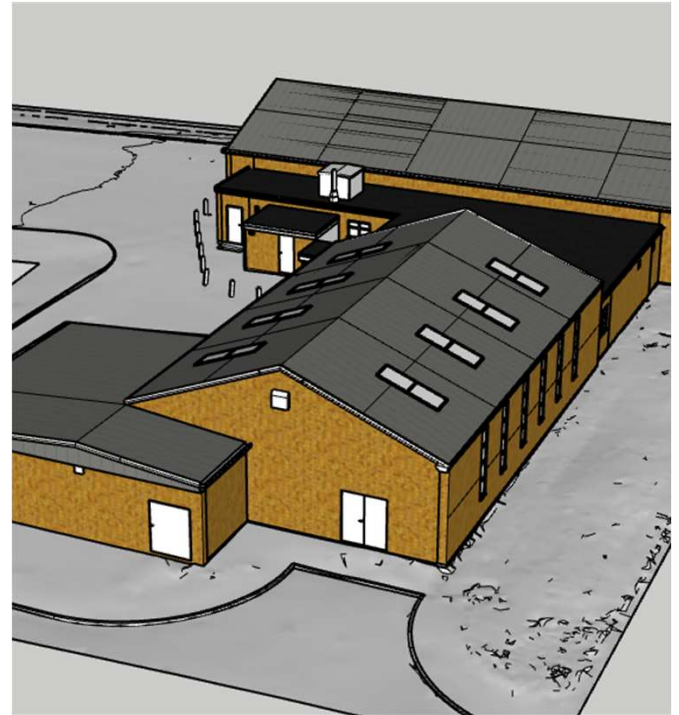
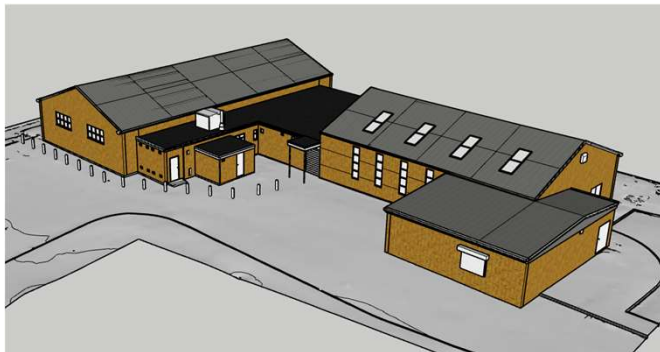
3D model snapshots of existing building

The current building was constructed in c. 1973. The only known refurbishment was undertaken in c. 2005 when some additional internal walls were added to create accessible toilets.

The primary structures and external fabric are in a reasonable condition with only relatively minor repairs required to cracked brickwork and to fix a leak to the hall roof.

The internal condition of the building is poor, particularly the finishes, fixtures and fittings to the changing rooms and around the pool area.

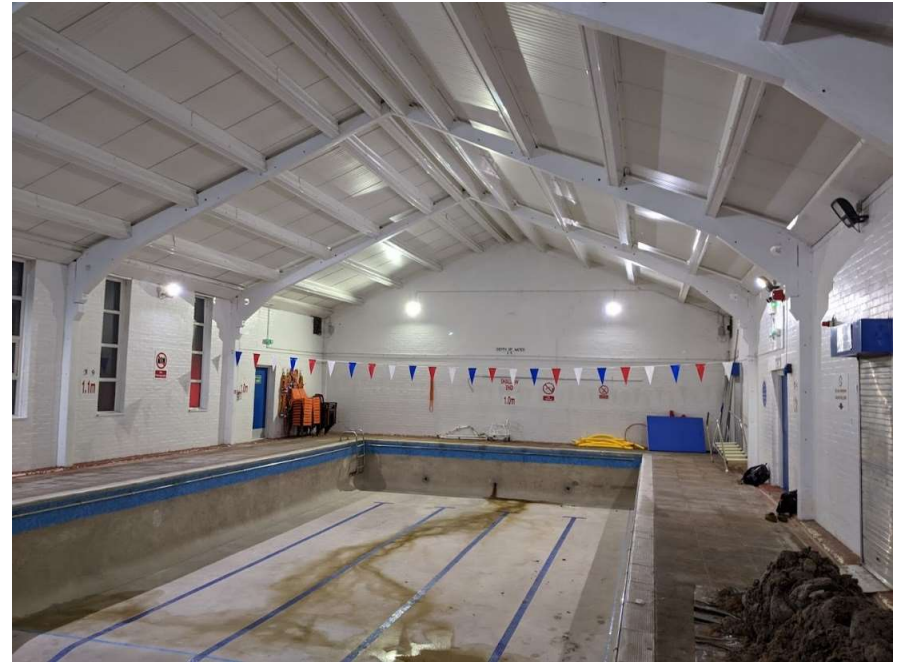
(Above) Existing condition of pool

Cracking and holes in the pool need to be repaired with waterproofing reinstated where required.

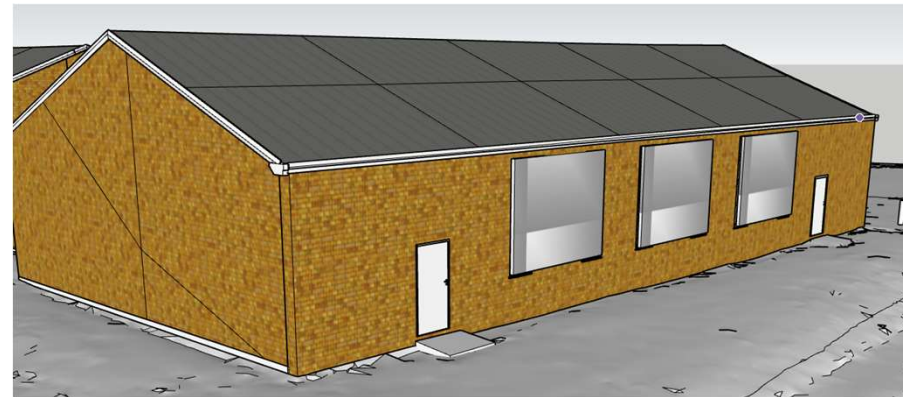
(Above) Possible enlarged windows. Could also look at something to north and south elevations and/or roof lights

- Remodel external elevation(s) to allow more light into the pool area (one way glass);
- Refurbish internal pool area as per Option 3;
- Refurbish changing rooms as per Option 4; and
- Keep hall open and meeting room open as currently.

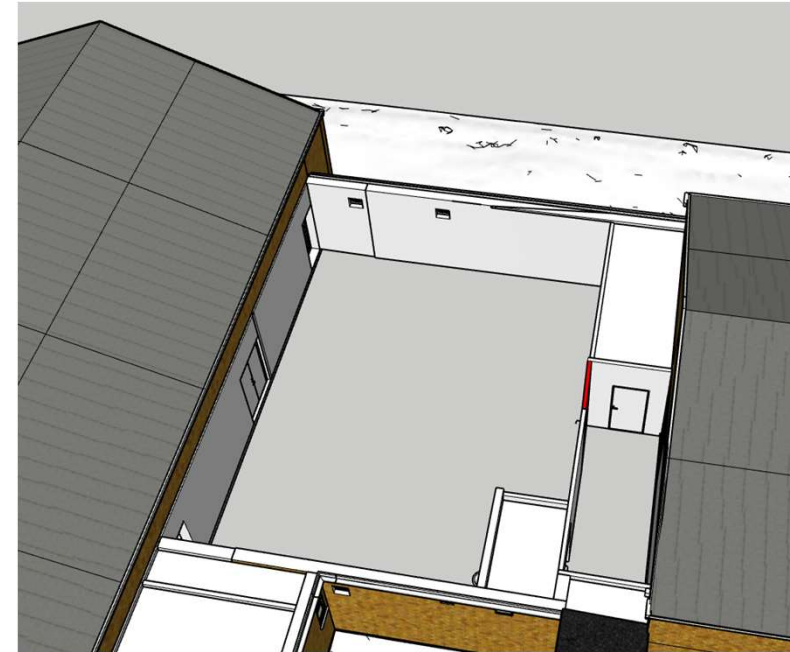
(Above) Existing changing rooms area with all walls removed. Layout to be developed, current pool office could also possibly be utilised.

- Refurbish pool area as per Option 3;
- Remodel changing rooms:
 - Remove all non-structural walls and investigate options for minimising structural ones (structural engineer to advise);
 - Remove corridor and create single changing space (options to be developed with architect); and
 - All new finishes, fixtures and fittings.
- Keep hall open and meeting room open as currently.

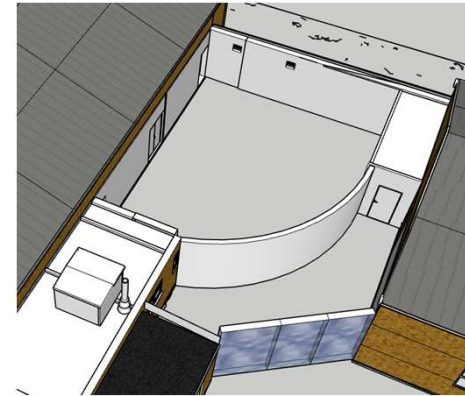
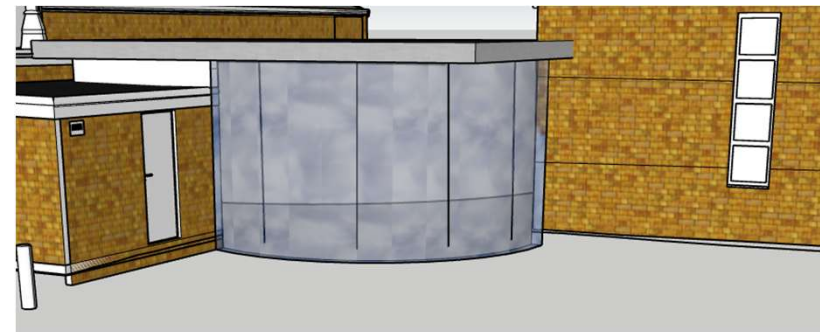
(Above and below) Possible new entrance and remodelled changing rooms

- Refurbish pool area as per Option 3;
- Remodel changing rooms similar to Option 5;
- Create new entrance and reception area (options to be developed with architect); and
- Keep hall open and meeting room open as currently.

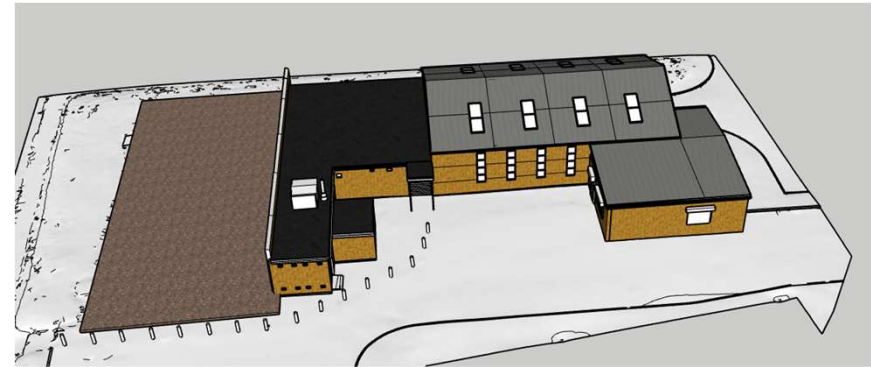
(Above) Example model if plant room can be retained. Area to west shown as MUGA.

- Demolish pool superstructure and fill in pool;
- Demolish changing rooms and entrance area (if possible);
- Retain or construct new plant room to service hall and meeting room;
- Create external multi-use games area (would need to have tennis court minimum to meet covenant); and
- Keep hall open and meeting room open as currently.

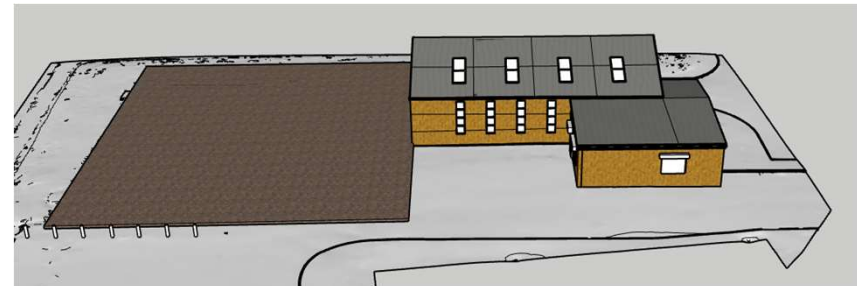
(Below) Example model if plant room and changing rooms are also demolished (allowance would need to be made for new plant room)

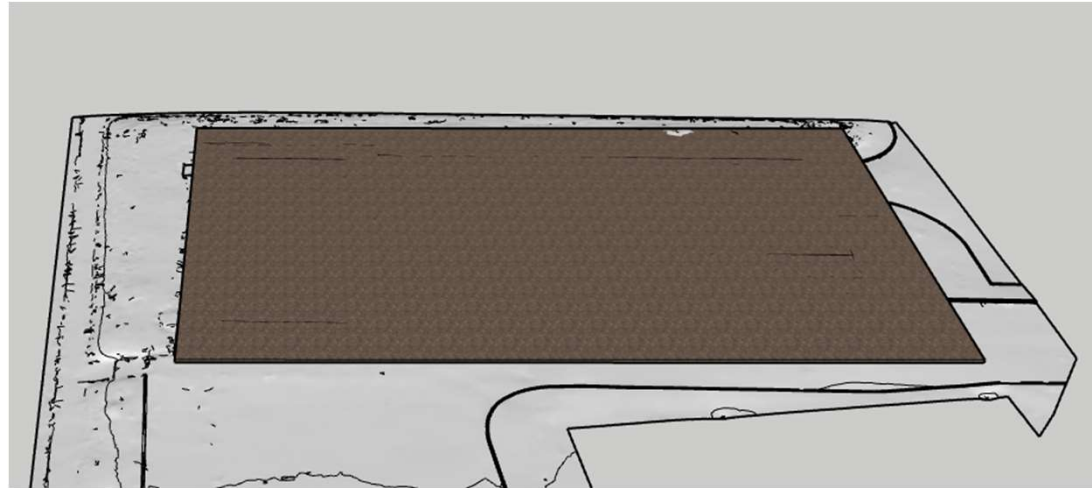
(Below) Model of all structures demolished on the site

- Demolish all structures, fill in pool and cover as appropriate; and
- Create external multi-use games area (would need to have tennis court minimum to meet covenant).

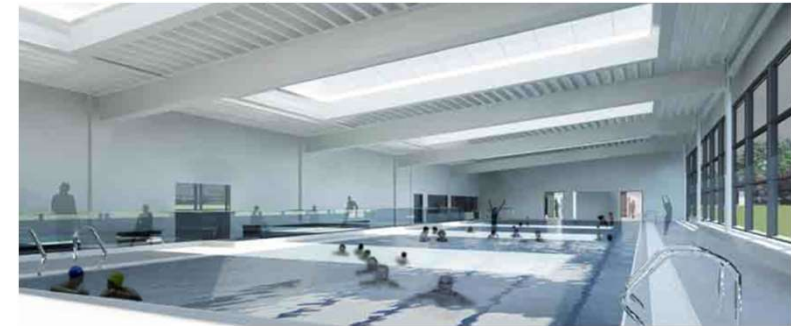
Typical section

Images shown are taken from Sports England guide to new community swimming pools design, 2011

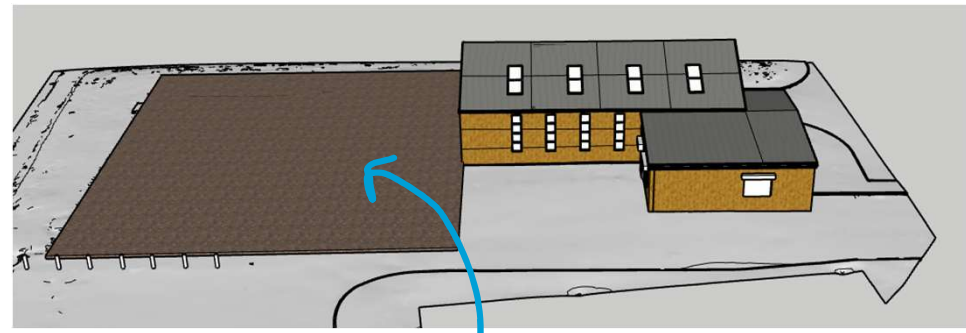
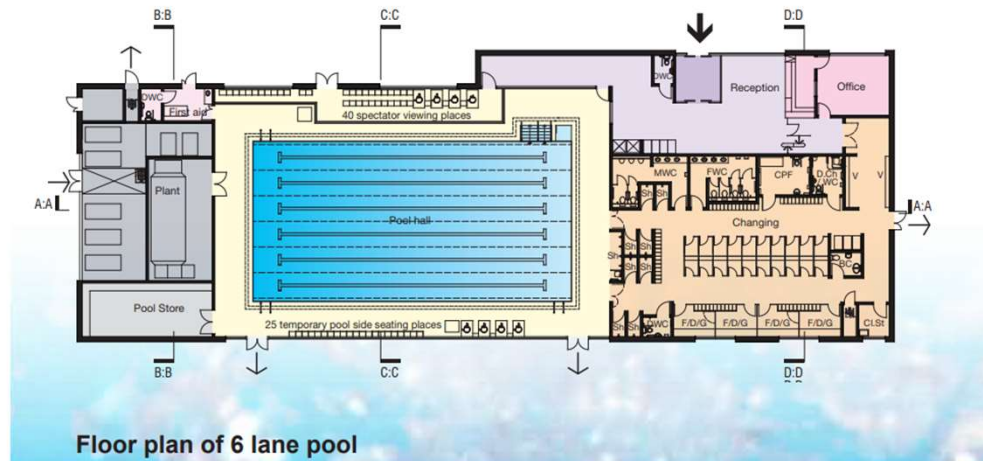
Locate new pool and changing rooms here

- Demolish pool, changing rooms, entrance and plant room;
- Redesign pool and changing rooms to modern building requirements; and
- Retain hall and meeting room.
